2018-09-17

Re: Project to remove trees by Grand Forks airport to construct a road on existing road right-of-way.

# Kettle Ecological

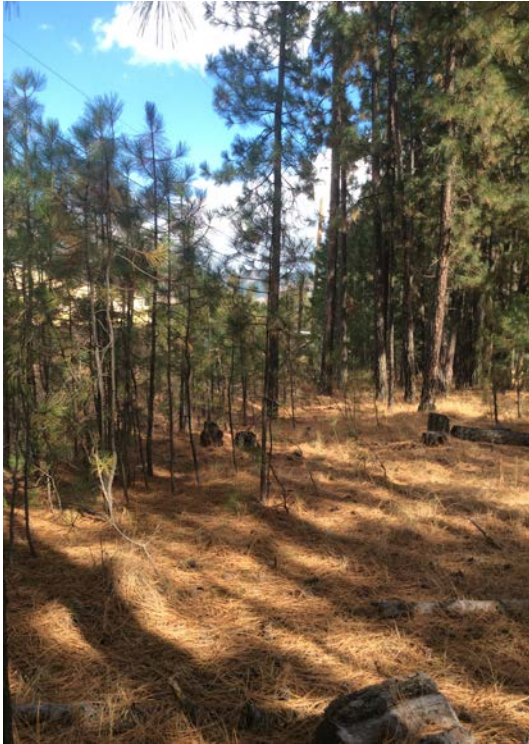
The habitat value of the stand on the road right-of-way currently is low since the stand is young (Picture 1 and 2), canopy is open, the trees have not yet matured sufficiently to provide unique features like heavy branches or rot pockets in the stems, and there is no evidence of excavated nests or platform nests. There are a few large diameter trees (>40 cm dbh) on the road right-of-way that will be removed by the project that would be considered future recruitment wildlife trees. It takes a long time to grow a large tree so considering future wildlife tree recruitment is important. As they mature they would have become more valuable to wildlife so the complete tree removal on the road right-of-way will have a small long-term impact. All the small diameter trees on the road right of way are of low habitat value and should be removed to create a

Picture 1. Young trees along road right of way to be harvested (looking east)

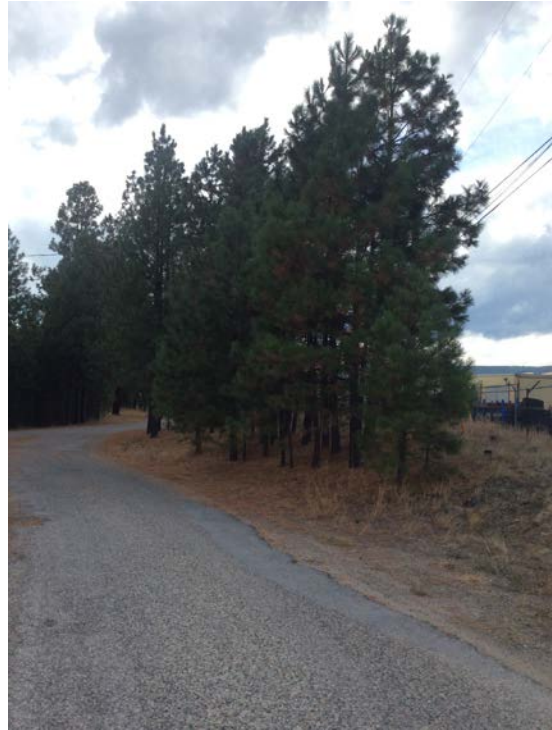
Picture 2. Young clump along road right of way on east end looking west.

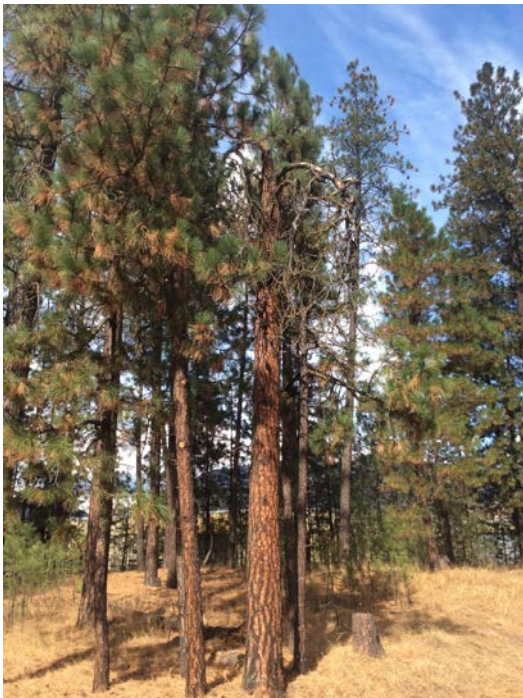
Picture 3. Higher value broken top tree in the retention area.

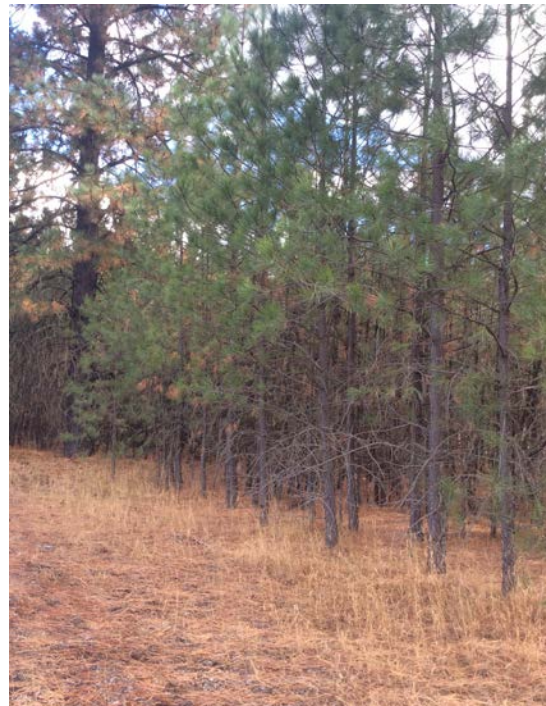
On the project site the stand of ponderosa pine trees (*Pinus ponderosa*) has a mix of age classes but overall is a fairly young stand with extensive ingrowth due to fire suppression (picture 4). Forest ingrowth is a common issue in the Ponderosa Pine bunchgrass Biogeoclimatic Zone in our area as a result of history of fire suppression that can be addressed through better management practices. A healthy high value stand of trees in this hot dry valley bottom site would be widely spaced clumps or individual trees of mature ponderosa pine (<40 dbh) with some dead or defect trees (broken top, spike top, presence of rot) with an understory of primarily bunchgrass and a few widely spaced shrubs. I did observe a small amount of woodpecker feeding on some larger trees within the retention area along with a couple larger broken top trees (picture 3). I did not observe any obvious wildlife use on trees within the road right-of-way. There are invasive weeds in the non-forested portions of the road right-of-way that will be removed as the road surface is built (Picture 5).

Picture 4. Young tree in-growth in the retention area that should be removed.

2. Habitat improvement should be undertaken within the retention area to remove young ingrowth and create coarse wood debris. This should include removal of all trees with a diameter at breast height (dbh) of less than 7 cm dbh and removal of 90% of the trees between 7 cm and 30 cm dbh. This should remove about 80% of the stems from the site opening up the canopy to release the grasses and forbs growing in the understory. The 10% of trees between 7 cm and 30 cm dbh to be retained should be the ones located in proximity to or within clumps of larger trees being retained to create a clumpy distribution. A few medium diameter trees harvested from the road right-of-way should be placed as coarse woody debris in the retention area to create habitat for snakes and small mammals. Ensure the equipment operators do all work in the retention area in a manner to minimize damage to trees and soil disturbance. There is a large opening between tree clumps within the current loop road where a few small ponderosa pine should be planted or transplanted. This opening was likely a result of previous construction work.

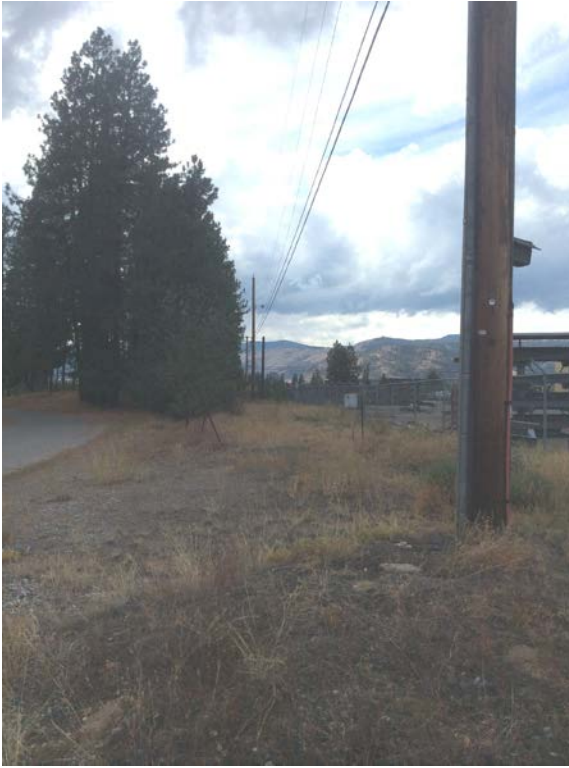
Picture 5. Invasive plants on existing road right of way that will be removed by construction of the road.

1. After the road is constructed all disturbed areas beyond the road surface should be revegetated with suitable drought resistant grass mix to prevent establishment of invasive plants. Specific recommendations have been provided in a separate email.
