Re. 2nd Street and Market Avenue Traffic Control Analysis, Grand Forks BC

As requested, we have completed a thorough review of the traffic patterns and safety at the existing intersection of 2nd Street and Market Avenue in Downtown Grand Forks to determine if a four-way stop is justifiable. Our analysis has entailed a site visit, traffic counts, traffic analysis, and a safety review. The analysis and findings are outlined in the sections below.

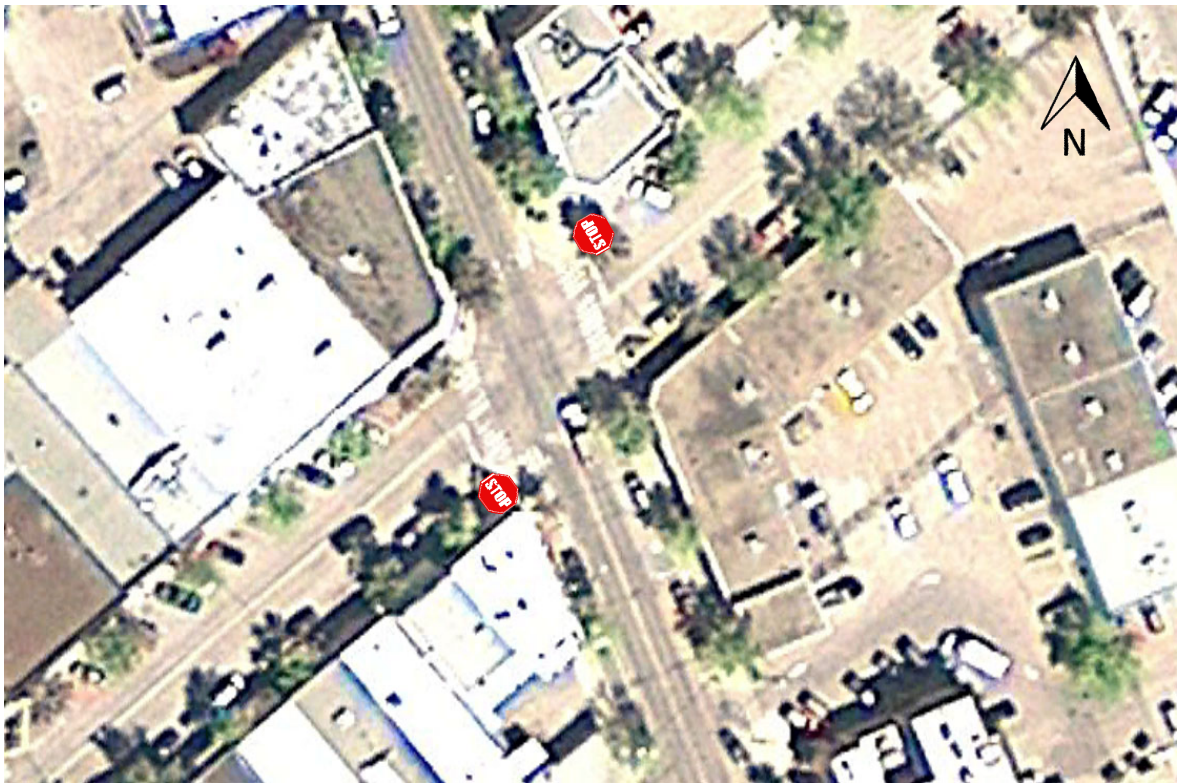
The existing intersection of 2nd Street and Market Avenue has existed as a two-way stop for decades (Figure 1). There are zebra (striped) crosswalks across all four approaches. The crosswalks across the Market Avenue approaches are at stop conditions, and have alternating red and white stripes. The crosswalks on the 2nd Street approaches are at a free-flow traffic condition, and do not currently have crosswalk signs.

Figure 1: Intersection of Second Street and Market Avenue

1. Install post-reflectors on the existing stop signs on Market Avenue.
2. Convert the existing zebra crosswalks on the Market Avenue approaches to parallel lines to complement the stop conditions.
3. Install pedestrian crosswalk signs on 2nd Street, as warranted by the crosswalks.
4. Ensure the intersection sight lines are kept clear, especially for traffic on the Market Avenue approaches. If concerns arise, consider the removal of the on-street parking stalls on Second Avenue which are immediately next to the Market Avenue intersection and/or the formal reduction of the posted speed on 2nd Street to 40 km/h through the Downtown.

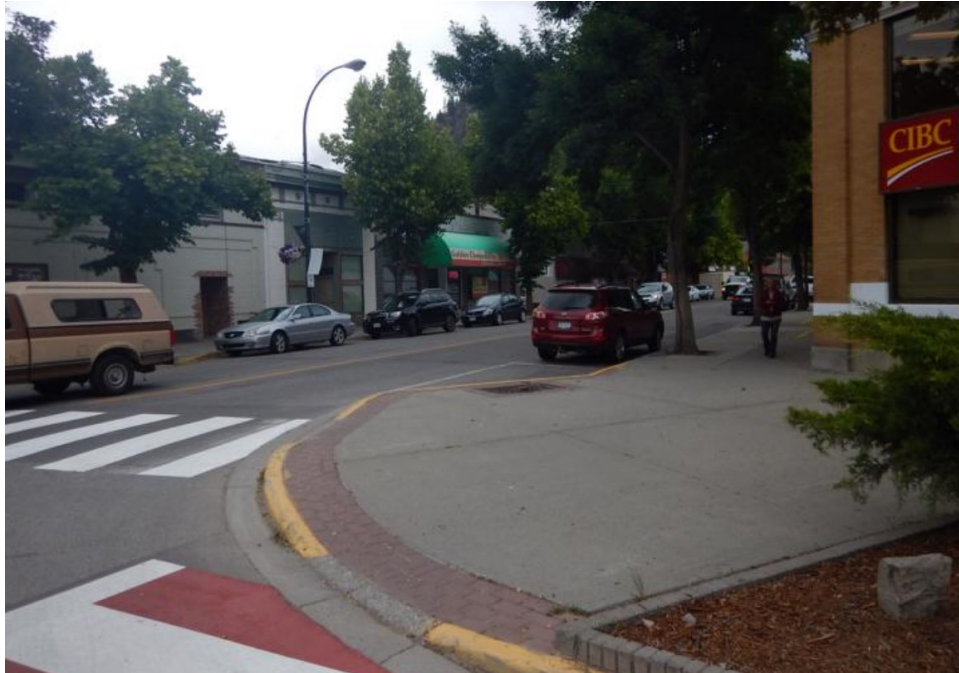
The intersection is on a skew of approximately 70 degrees. Sidewalk extensions (“corner bulbs”) are provided on all four corners to help manage traffic speeds on 2nd Street. On-street parking is available on 2nd Street immediately upstream and downstream of each sidewalk extension (Figure 2). Depending on the size of the vehicles parked adjacent to the sidewalk extensions, the sight distance for drivers on Market Avenue looking at approaching traffic on 2nd Street is approximately 40-50 metres in each direction, which corresponds to a 40 km/h design speed (based on guidelines from the Transportation Association of Canada (TAC)). Without vehicles parked on the corners, these sight distances increase to 60-70 metres, which corresponds to a 50 km/h design speed.

Figure 2: On-Street Parking Effect on Sight Lines – Looking North
